**Stage 1 Road Safety Audit  
Phase 1 Residential Development  
Ballykeeran Gardens, Cornamaddy,  
Athlone, Co. Westmeath**

**Phase 1 Residential Development Ballykeeran Gardens, Cornamaddy, Athlone,  
Co. Westmeath  
Stage 1 Road Safety Audit**

| <b>Document No:</b> | 251416-ORS-XX-XX-RP-TR-13g-001_S1_RSA |

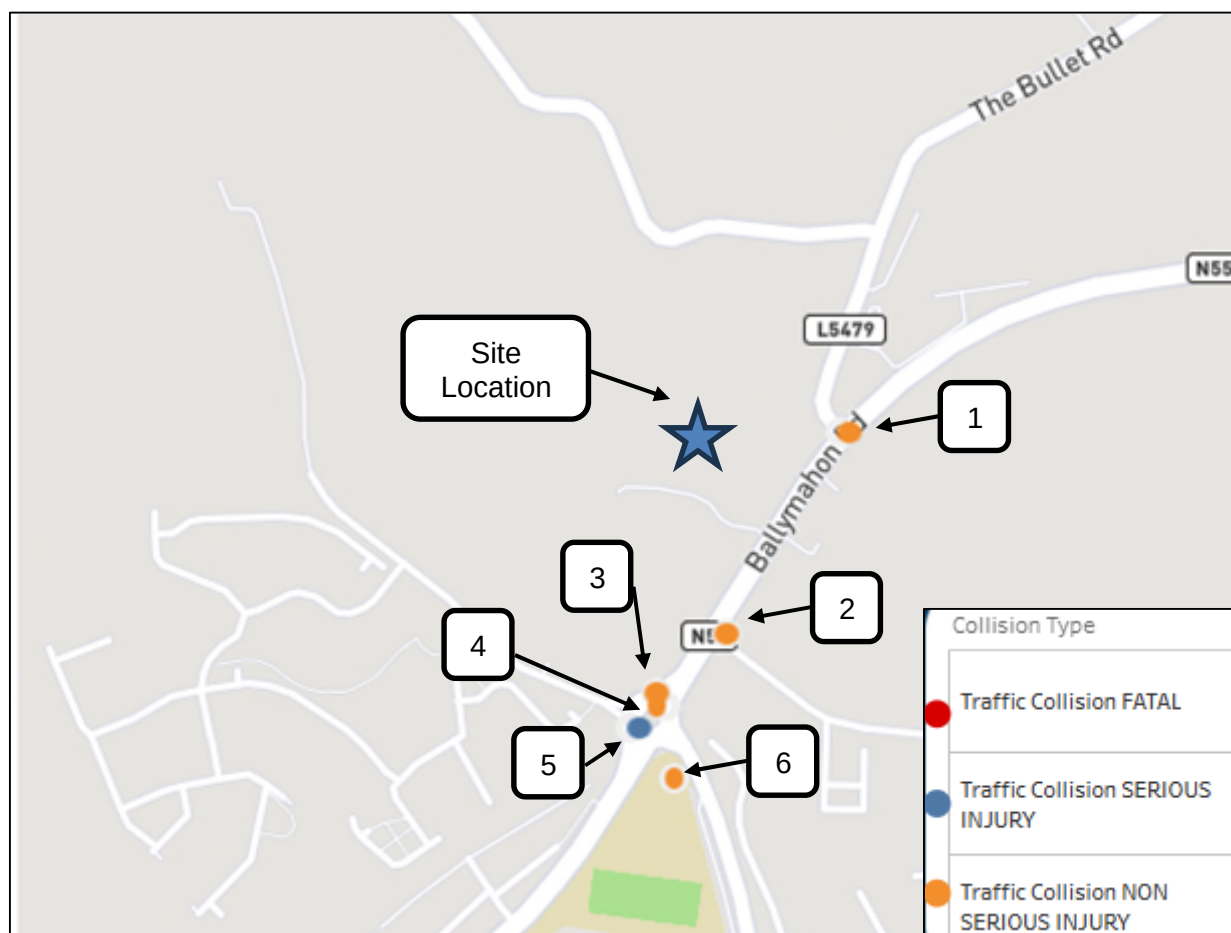
**Figure 3.1:** Collision history in the vicinity of the site (2016-2024) (Source: RSA Map of Collisions)

**Figure 3.1** illustrates the locations of recorded collisions within the wider study area, which includes incidents near the proposed access point. The numerical identifiers (1-6) assigned to the incidents listed below correspond directly to the markers displayed in **Figure 3.1**.

- 1. Junction of Ballymahon Rd (N55) and Blyry Ct (September 2016 | 8am - 11.59am): Non-serious injury collision - 1 driver minorly injured.
- 2. Junction of Ballymahon Rd (N55) and The Orchard (April 2016 | 4pm - 7.59pm): Non-serious injury collision - 1 cyclist minorly injured.
- 3. Roundabout joining the N55 and R916 (May 2018 | 8am - 11.59am): Non-serious injury collision - 1 driver minorly injured and 2 passengers minorly injured.
- 4. Roundabout joining the N55 and R916 (June 2019 | 4pm - 7.59pm): Non-serious injury collision - 1 cyclist minorly injured.
- 5. Roundabout joining the N55 and R916 (February 2021 | 12pm - 3.59pm): Serious injury collision - 1 cyclist seriously injured.
- 6. Near the roundabout joining the N55 and R916 (August 2024 | 4pm - 7.59pm): Non-serious injury collision - 2 pedestrians minorly injured.

Although the immediate vicinity of the development site maintains a clean safety record, the incidents recorded in the wider study area, particularly those involving vulnerable road users, underscore the importance of ensuring that appropriate safety measures are incorporated into the design. This includes maintaining clear visibility splays and safe turning provisions at the new development access point to protect all road users.

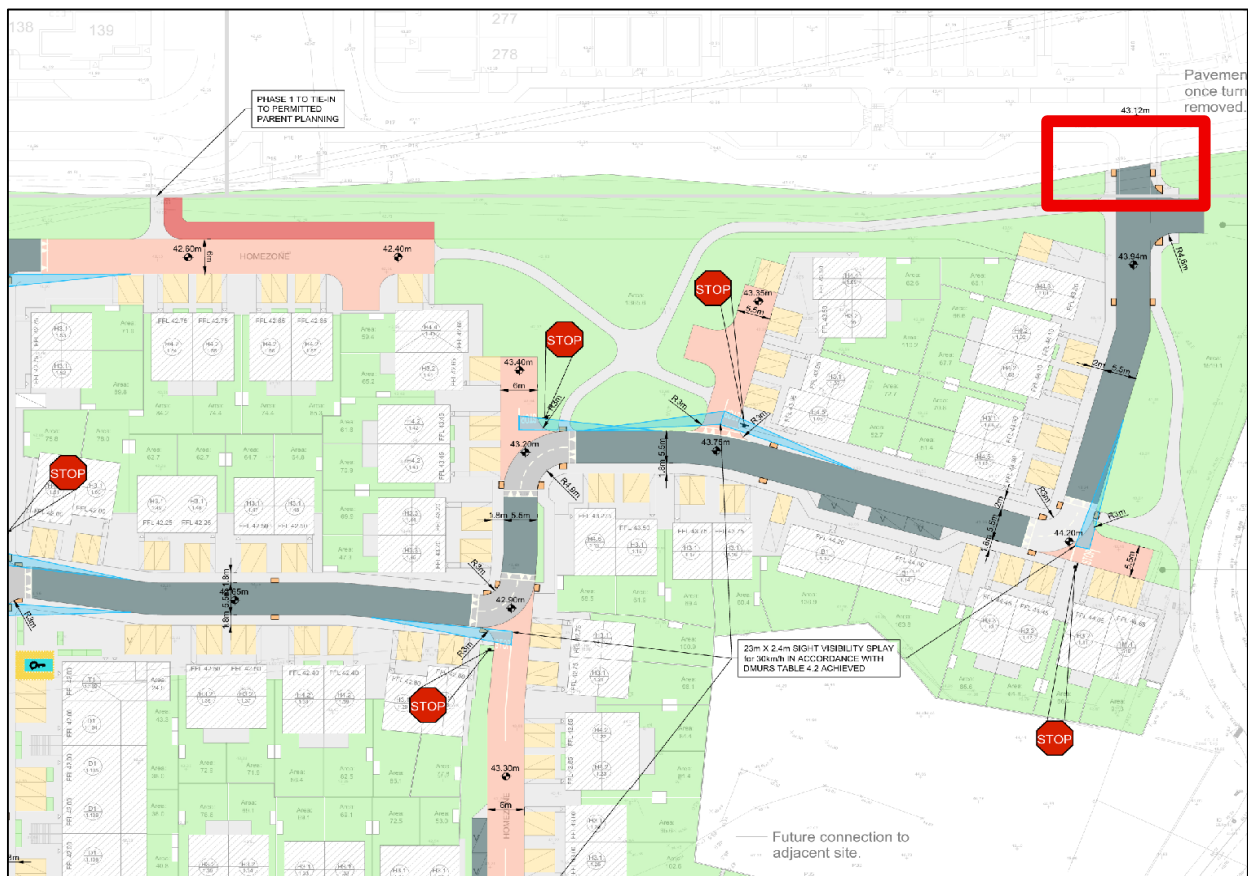
#### Problem No.01: Absence of Pedestrian Crossings and Tactile Paving on Desire Lines

The audit team note that formal pedestrian crossings, dropped kerbs, and tactile paving have been omitted along natural pedestrian desire lines, particularly at the identified junctions. Without designated crossing points, pedestrians may be forced to step off full-height kerbs and cross at uncontrolled locations. Furthermore, the lack of hazard warning tactile paving prevents visually impaired users from identifying the boundary between the safe footpath and the active carriageway, increasing the risk of pedestrian falls and vehicle-pedestrian conflicts.

The design team should ensure that the dedicated crossing points are positioned on desire lines to mitigate the safety risk identified. The images shown are only examples and the check should not be confined to these locations.

| Problem Reference in Safety Audit Report | To Be Completed by the Designer | | | To be Completed Audit Team Leader |
|---|---|---|---|---|
| P01 | N | N | Crossing point will be provided on desire line on future norther junction. This area identified will terminate at this location. | Yes |

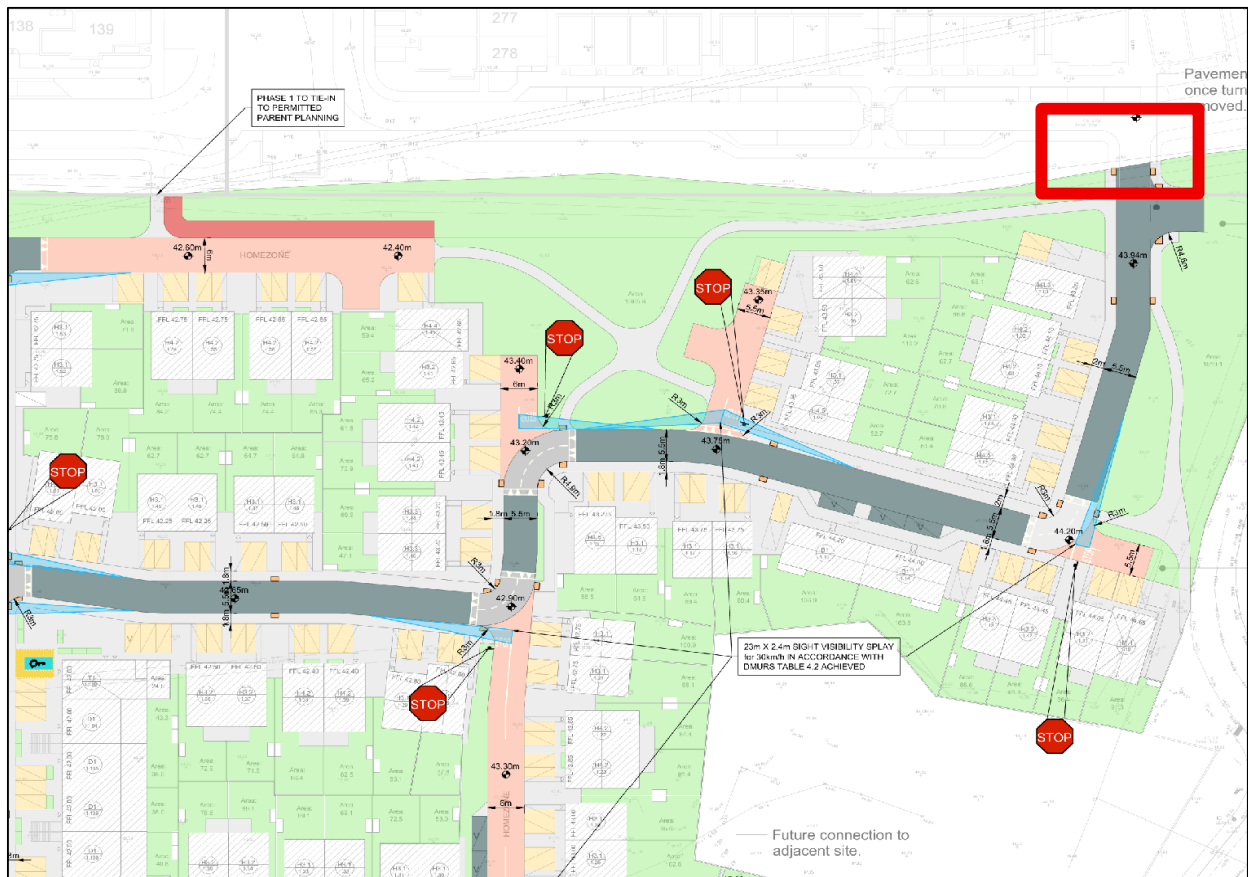
## Problem No.02: Unclear Tie in Between Development to North and Proposed Development Access Roads

The drawing indicates a connection between the existing development road network and the proposed Phase 1 roads; however, the detailed junction arrangement, priority control, carriageway alignment and transition between the existing and proposed layouts are not clearly defined on the submitted drawing. This may create uncertainty for drivers regarding right-of-way and vehicle positioning, particularly during the early occupation phases of the development and while construction traffic is present. The lack of a clearly legible junction form could increase the risk of side-impact and turning collisions.

| Problem Reference in Safety Audit Report | To Be Completed by the Designer | | | To be Completed Audit Team Leader |
|---|---|---|---|---|
| P02 | Y | Y | Northern development will tie in with southern development in the future. | |

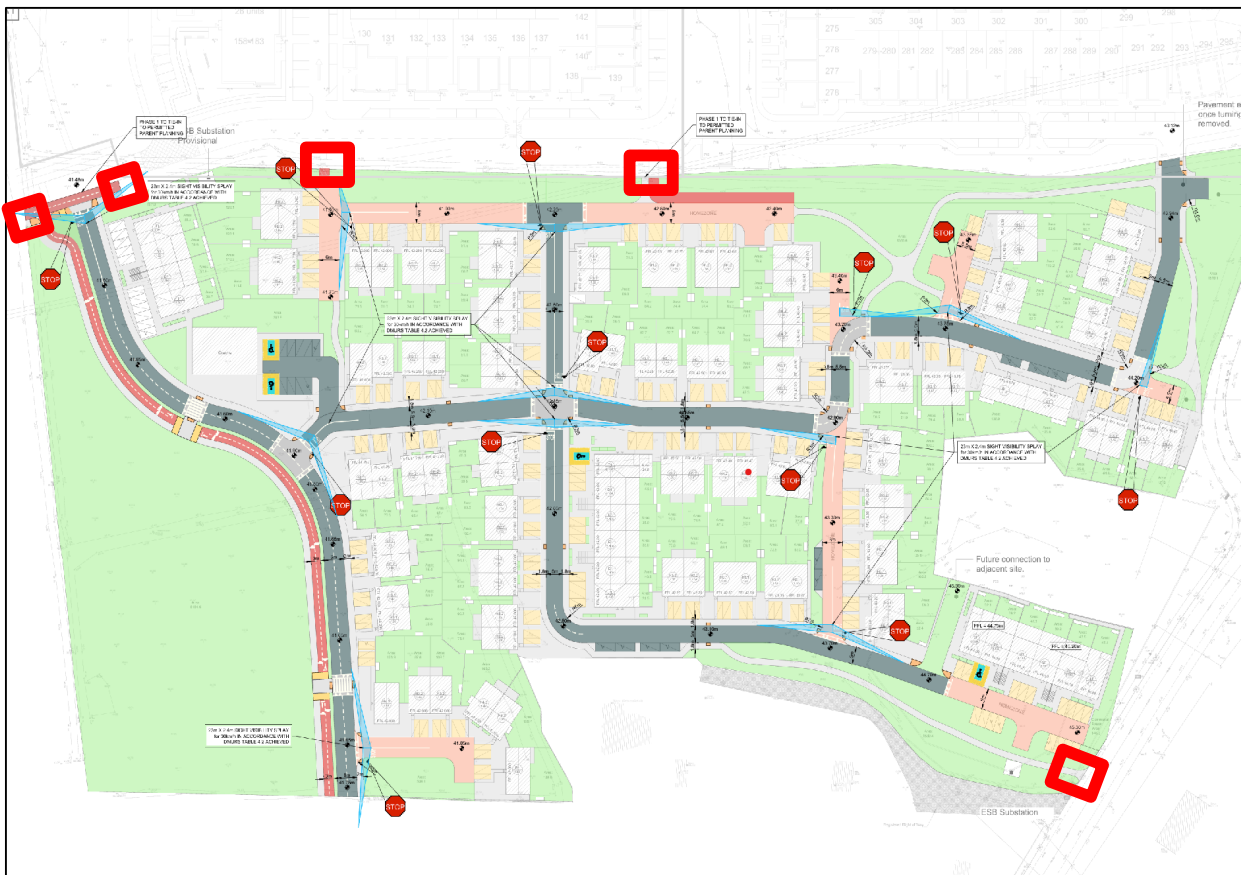
### Problem No.03: Tie-in to Footpaths and Cycle Tracks to Existing Infrastructure to East and Development to North

The submitted layout does not clearly demonstrate how the proposed footpath and cycle route network will tie into existing pedestrian and cyclist infrastructure or the future development lands to the north. The lack of a clearly defined connection strategy may result in pedestrians and cyclists being directed onto carriageways, crossing undesigned locations, or using informal routes. This could reduce network permeability and increase the potential for conflict between vulnerable road users and vehicles, particularly when future phases of development are delivered.

The design team should ensure clear details of how pedestrian and cyclist facilities will connect to existing and future infrastructure beyond the site boundary. Continuous routes should be provided with appropriate widths, surfacing, priority arrangements and crossing facilities. Any temporary termination of footways or cycle routes should be designed to safely accommodate users until future connections are delivered.

| Problem Reference in Safety Audit Report | To Be Completed by the Designer | | | To be Completed Audit Team Leader |
|---|---|---|---|---|
| P03 | Y | Y | Northern development will tie in with southern development in the future. | |

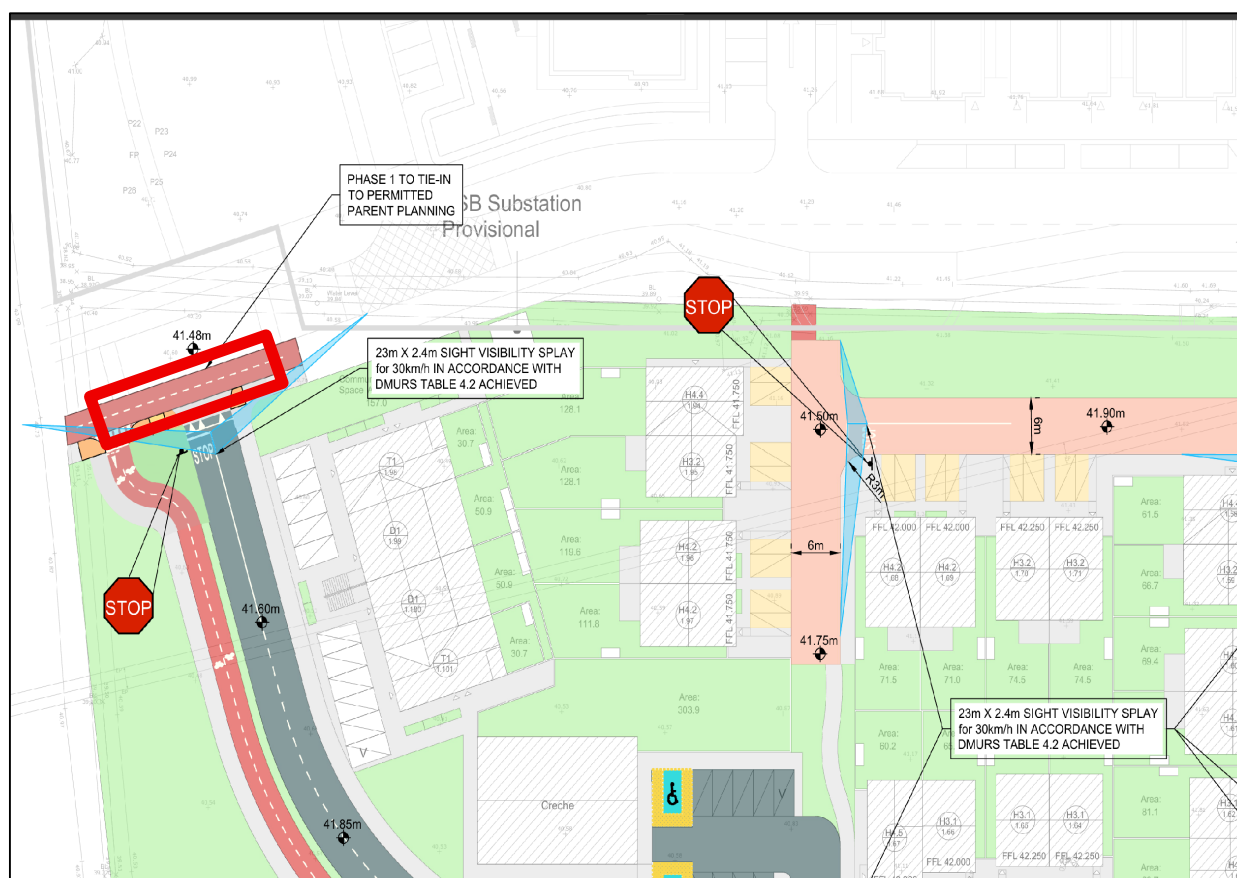
## Problem No.04: Absence of Cycle Track Markings along Junction with Northern Development to Indicate Cyclist Priority

The submitted layout does not indicate cycle track markings, coloured surfacing, or other measures at the junction with the northern development to clearly communicate the presence and priority of cyclists crossing side-road movements. In the absence of such measures, drivers entering or exiting the adjoining development may not anticipate cyclists travelling along the active travel route, increasing the risk of vehicle-cycle collisions, particularly where visibility and user expectancy may be reduced

The design team should ensure the junction arrangement and provide appropriate measures to clearly identify the cycle route and communicate cyclist priority. Consideration should be given to coloured surfacing, cycle crossing markings, continuous cycle track treatments across side-road junctions, road markings, and associated signage in accordance with current active travel design guidance. The design should ensure that priority arrangements are clear and readily understood by all road users

| Problem Reference in Safety Audit Report | To Be Completed by the Designer | | | To be Completed Audit Team Leader |
|---|---|---|---|---|
| P04 | Y | Y | RRM 023 edge of cycle track marking added. (Refer to ORS drawing 700 for details) | |

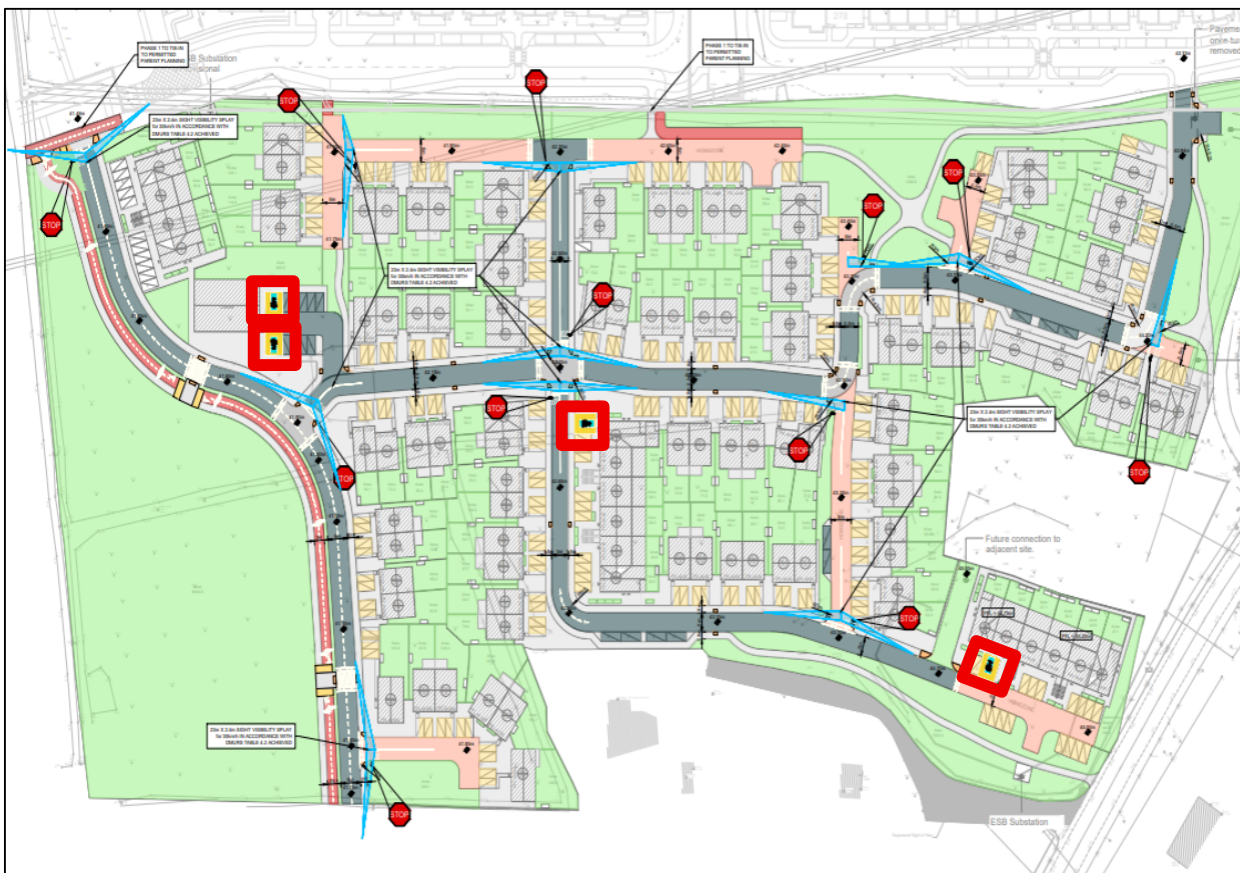
## Problem No.06: Accessibility of Disabled Parking Spaces

The audit team notes that accessible parking spaces are indicated within the proposed development. However, it is not clear from the drawings provided whether appropriate dropped kerbs and accessible routes are provided adjacent to these spaces. In the absence of dropped kerbs, wheelchair users and other mobility-impaired users may be unable to safely access the adjoining footway network directly from their vehicle. As a result, users may be forced to travel within the carriageway to locate a suitable crossing point or footpath access. This could increase the risk of conflicts and potential collisions between vehicles and vulnerable road users. Furthermore, the absence of suitable accessibility measures may discourage the safe and convenient use of the designated accessible parking spaces

The design team should provide adequate provision for users of the spaces to access the footpath safely.

| Problem Reference in Safety Audit Report | To Be Completed by the Designer | | | To be Completed Audit Team Leader |
|---|---|---|---|---|
| P06 | Y | Y | Dropped kerbs to be provided at all accessible parking spaces. | |

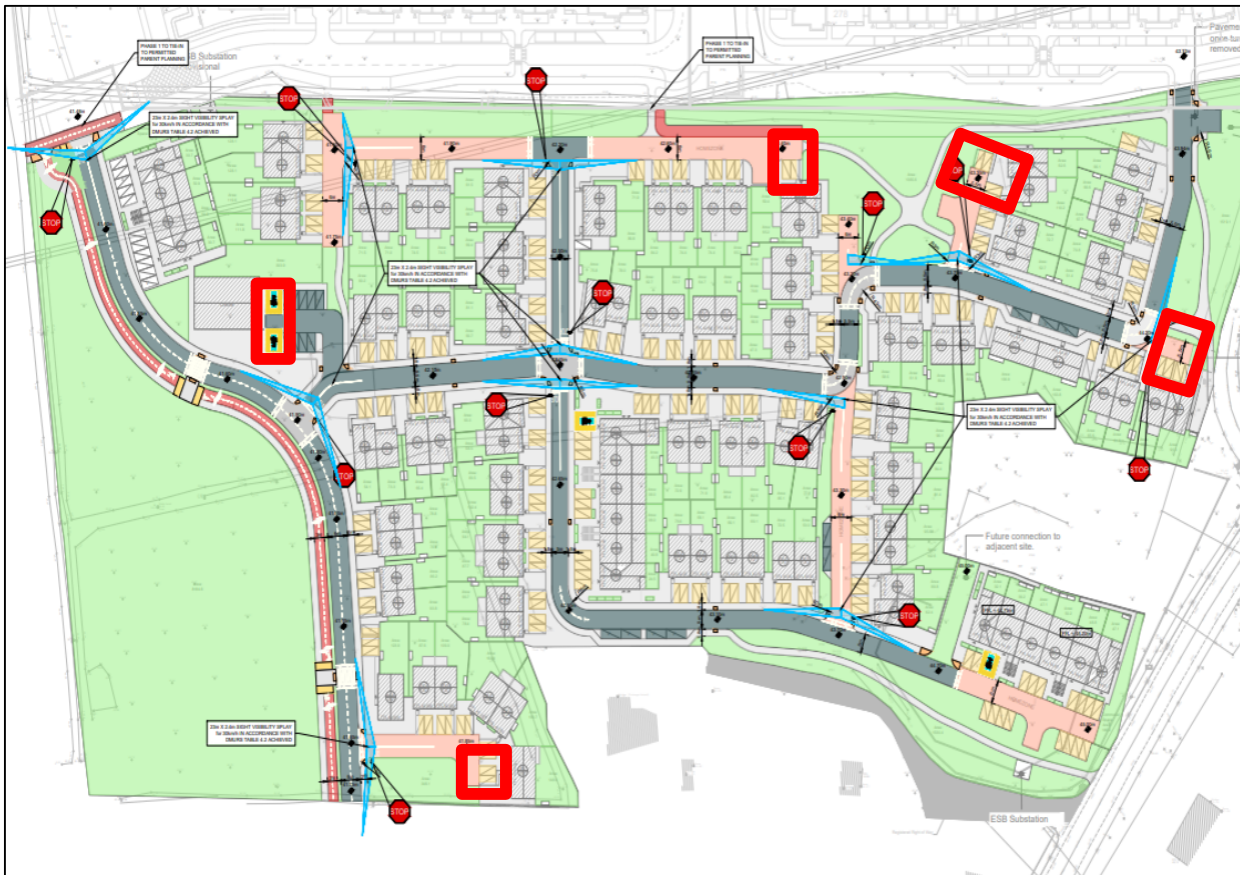
## Problem No.07: Restricted Car Parking Spaces Resulting in Difficult Manoeuvring

The audit team notes from the drawings provided that a number of the proposed parking spaces appear constrained by their location and surrounding geometry. It is not clear that sufficient manoeuvring space is available for all vehicle types to safely enter and exit the spaces. Restricted parking layouts may result in drivers undertaking multiple manoeuvres or reversing excessive distances to access the carriageway. This may increase the likelihood of vehicle-to-vehicle collisions, particularly in areas with frequent parking turnover. Furthermore, reversing vehicles may not readily detect pedestrians, cyclists, or other vulnerable road users travelling behind the vehicle, thereby increasing the risk of injury collisions.

The design team should ensure that adequate manoeuvring space is available for vehicles to safely enter and exit all parking spaces. Vehicle tracking should be undertaken where necessary to confirm suitability. Parking layouts should minimise the need for excessive reversing movements and ensure adequate visibility is available between drivers and pedestrians, cyclists, and other road users. Any constrained spaces should be redesigned to improve accessibility and user safety.

| P07 | Y | Y | (Refer to ORS drawing 730-733) | |

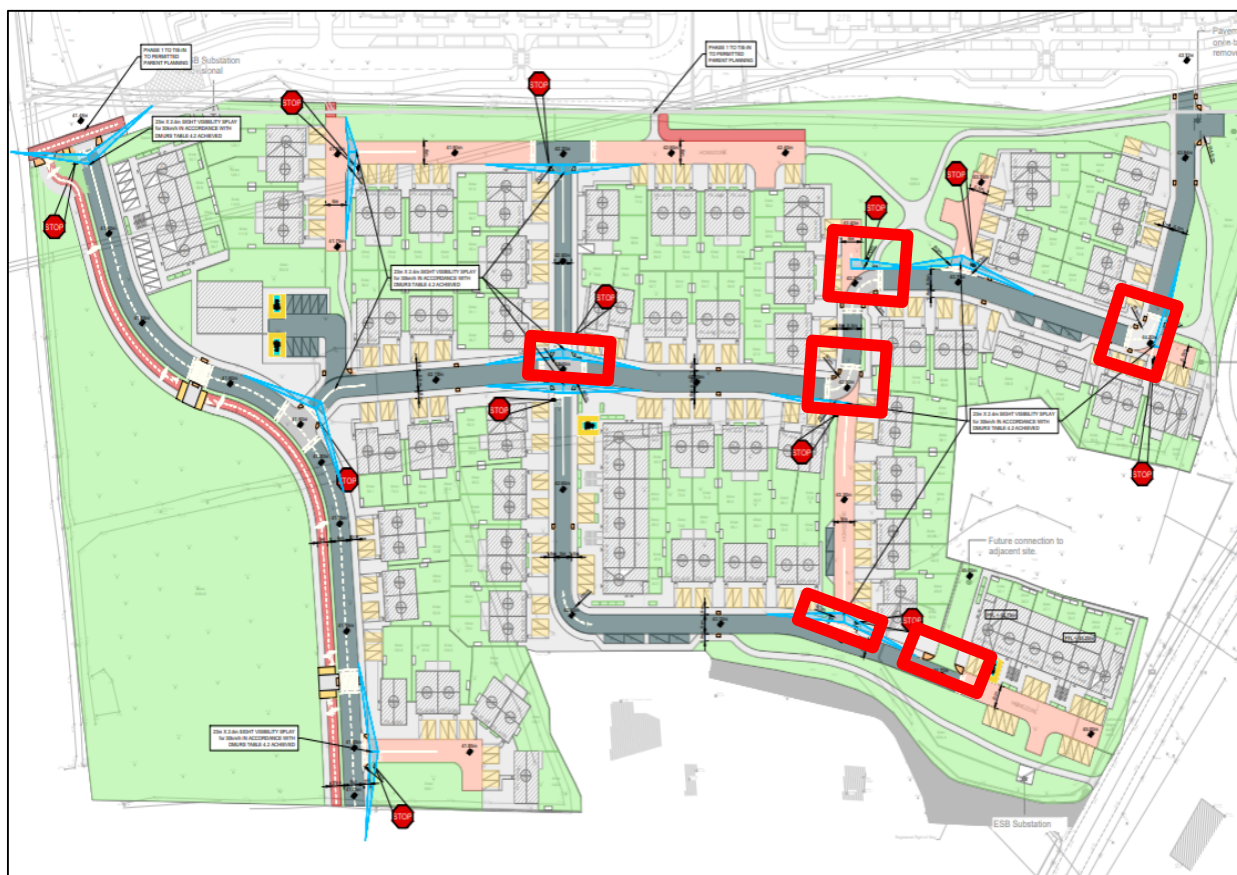
## Problem No.08: Private Parking Spaces Existing onto Raised Pedestrian Crossing

The audit team notes that a number of private parking spaces appear to access directly onto raised pedestrian crossing points. Vehicles exiting these spaces may need to reverse or manoeuvre across the crossing area before joining the carriageway. Drivers exiting private parking spaces may focus primarily on approaching vehicular traffic and may not anticipate pedestrians using the crossing immediately behind or adjacent to their vehicle. This is of particular concern for vulnerable road users, including children, elderly pedestrians and mobility-impaired users, who may reasonably expect the crossing facility to provide a safer pedestrian environment. The proximity of parking manoeuvres to the crossing may increase the potential for vehicle-pedestrian conflicts and collisions.

The design team should ensure the relationship between private parking spaces and raised pedestrian crossing facilities throughout the development have greater separation distances or amending the crossing layout to minimise conflicts between reversing vehicles and pedestrians. The design should ensure adequate visibility is available between drivers and pedestrians and that crossing points remain clearly identifiable and safe for use by vulnerable road users.

| P08 | Y | Y | (Refer to ORS drawing 700) | |

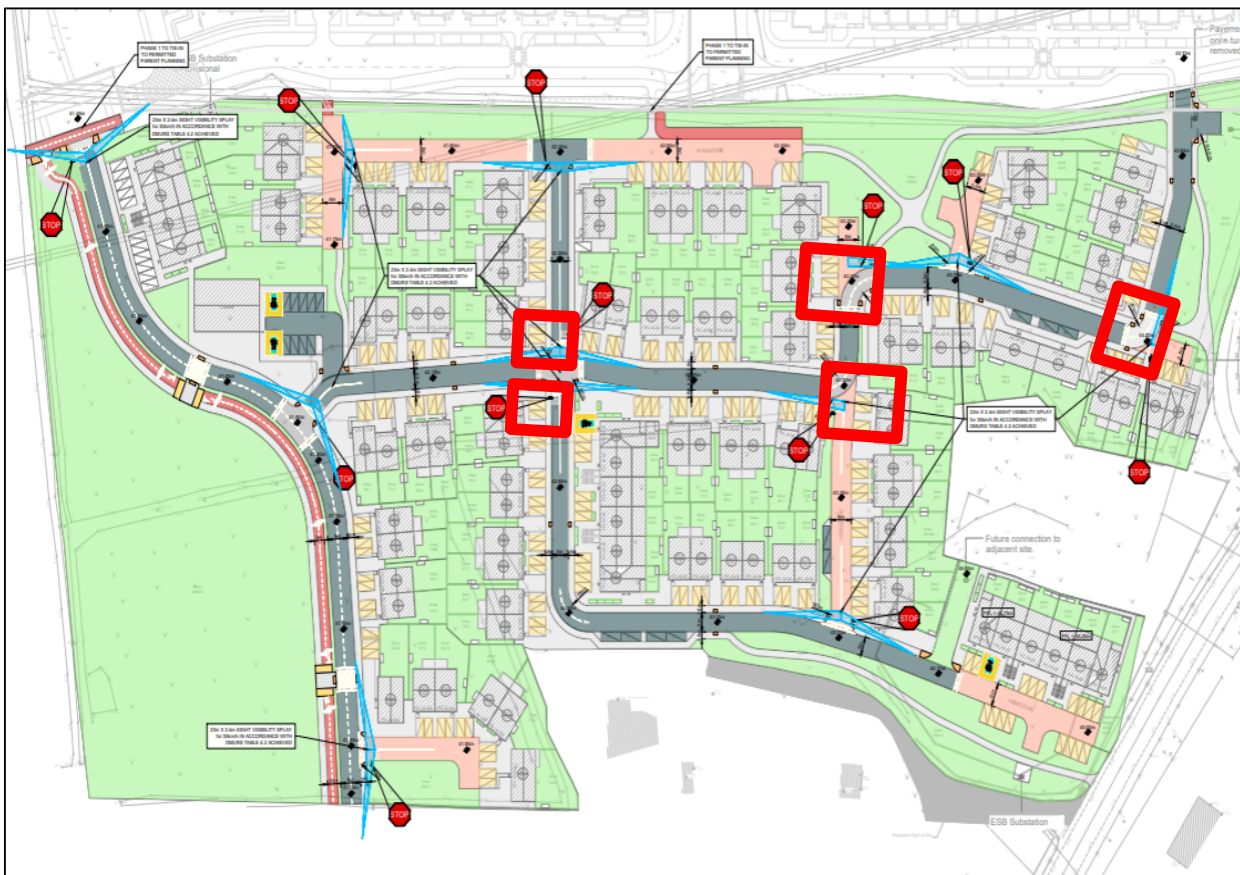
## Problem No.09: Private Parking Spaces Reversing into Priority Junction to Exit

The audit team notes that a number of private parking spaces appear to be located in close proximity to priority junctions, such that vehicles may be required to reverse from private driveways directly into, or immediately adjacent to, the junction area before proceeding onto the carriageway. Drivers reversing from these spaces may have restricted visibility of approaching traffic, pedestrians and cyclists, particularly where their attention is focused on manoeuvring their vehicle. Equally, drivers approaching the junction may not expect a vehicle to emerge in a reversing movement from a private parking space. The proximity of these manoeuvres to the junction can increase decision-making demands on road users and may result in vehicle-to-vehicle or vehicle-to-pedestrian conflicts. Vulnerable road users, including children and cyclists, may be particularly difficult to detect during reversing manoeuvres.

The design team should ensure the layout of private parking spaces situated adjacent to priority junctions and seek to minimise the need for vehicles to reverse into junction influence areas. The designer should also demonstrate that appropriate visibility is available between reversing drivers and other road users.

| P09 | Y | Y | (Refer to ORS drawing 700) | |

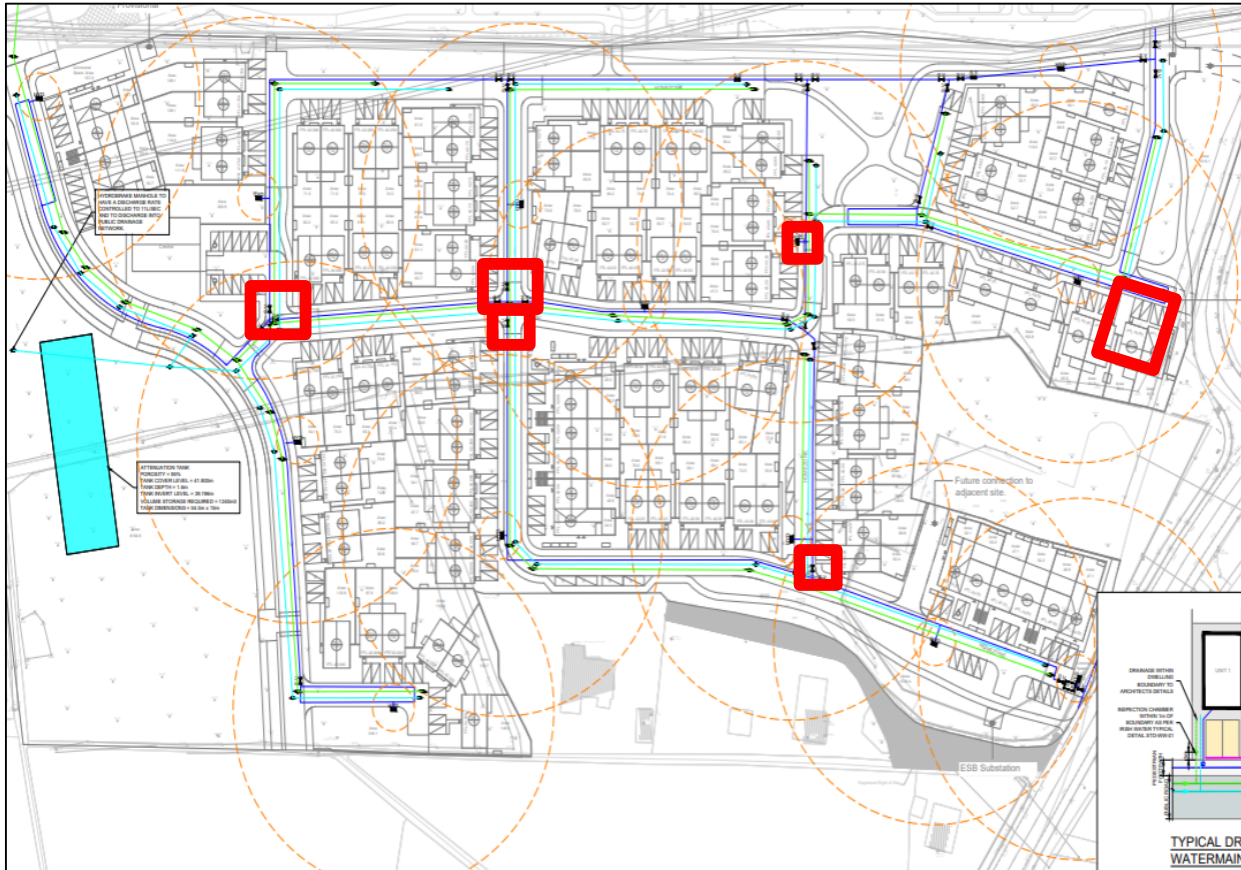
## Problem No.10: Utility Manholes within Crossing Zone

The audit team notes that utility manholes and service covers may be located within, or in close proximity to, pedestrian crossing zones. The presence of utility apparatus within crossing areas increases the risk of slips, trips and falls, particularly for visually impaired pedestrians, wheelchair users, mobility-impaired users, elderly pedestrians and those pushing prams or buggies. Furthermore, maintenance activities associated with utility covers may result in disruption to crossing facilities and pedestrian routes.

The design team should ensure the location of all utility manholes and service covers are outside of pedestrian crossing zones.

| P10 | Y | Y | Utility Manhole covers will be relocated outside of crossing zone. | |

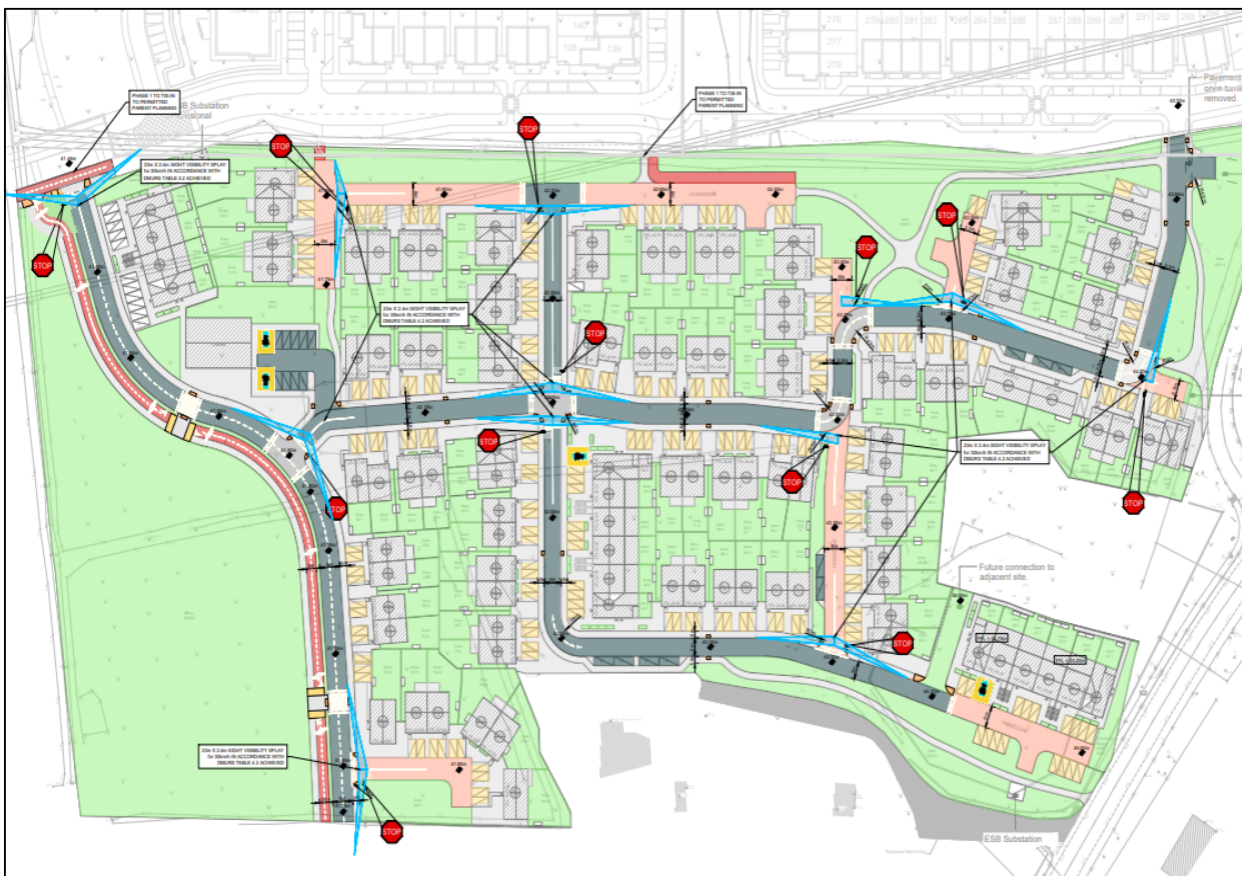
## Problem No.11: Absence of Cycle Track Signage Along the Cycle Track

The audit team notes that no cycle track signage is indicated on the drawings provided. In the absence of dedicated signage along the cycle route, cyclists may be uncertain as to the intended route alignment, continuation of the facility, priority arrangements at crossings, and connections to adjacent phases of development or external cycle infrastructure. Furthermore, where cycle tracks run adjacent to pedestrian facilities or intersect with vehicular routes, the absence of signing may reduce awareness among other road users of the presence of cyclists. This may lead to uncertainty, route deviation, and an increased risk of conflicts between cyclists, pedestrians, and vehicles, particularly at junctions, crossing points, and points where the cycle route changes direction.

The design team should ensure the proposed cycle network has appropriate cycle signage strategy along the length of the cycle track. Signage should clearly identify the cycle route, assist with wayfinding, indicate route continuity, and reinforce priority arrangements where applicable.

| P11 | Y | Y | To be provided at detailed design stage. | |

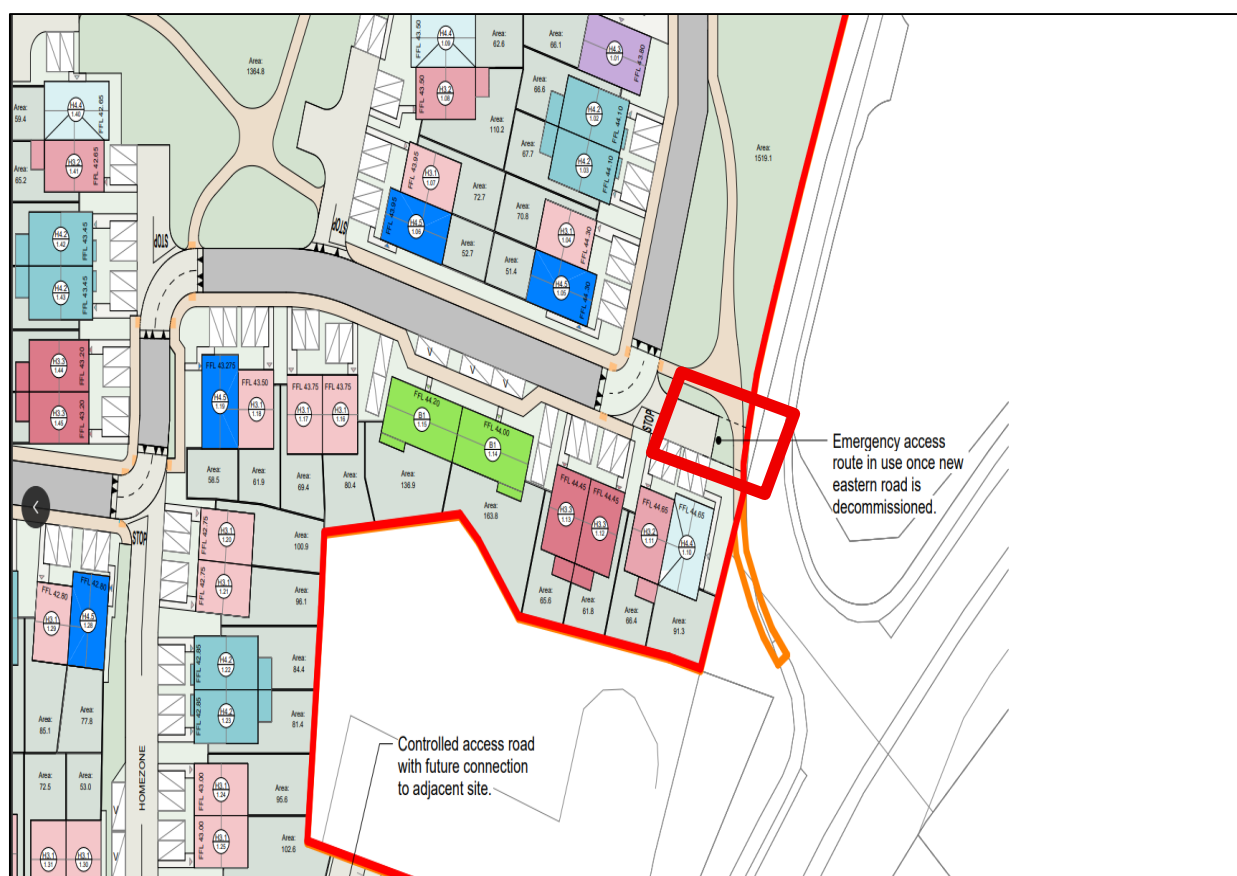
## Problem No.12: Potential Misuse of Emergency Access Route Following Removal of Eastern Road Connection

The audit team notes that the drawings indicate an emergency access route will remain in place following the removal of the eastern road connection and associated turning head arrangements. However, no details are provided regarding how access to this route will be controlled. If the emergency access route is not clearly identifiable and appropriately restricted, there is a risk that unauthorised vehicles may use the route as a through-route or for parking and manoeuvring purposes. Such activity could result in conflicts between vehicles and pedestrians using adjacent areas, particularly within this residential environment where vulnerable road users are expected to be present. In addition, unauthorised use or obstruction of the route may compromise its intended emergency access function and could delay emergency service response times when access is required

The design team should ensure the appropriate measures are put in place to control access to the emergency route and prevent unauthorised vehicular use.

| P12 | Y | Y | Bollards provided as per the parent permission. | |

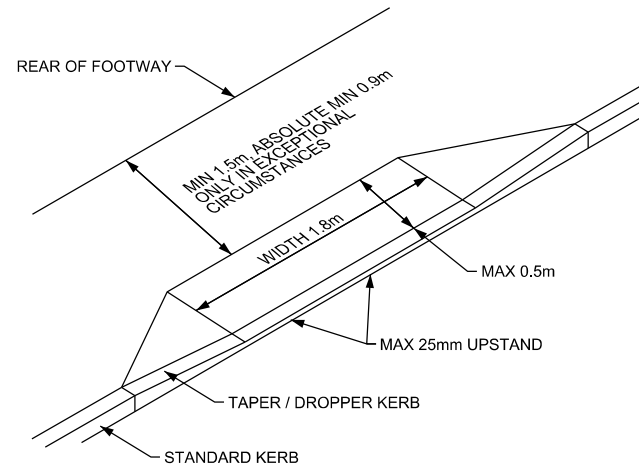
WITHOUT CORNER KERB

CONSIDERATION MUST BE GIVEN TO THE POTENTIAL FOR THE GROUNDING OF VEHICLES USING THE CROSSOVER AND HOW TO MITIGATE THIS.
